# Manhole Inspection Summary

Manhole # S51O\_\_026MH

Insp Date: **2/26/09 11:47 AM**

**Location** Address: **2815 odonnell st**

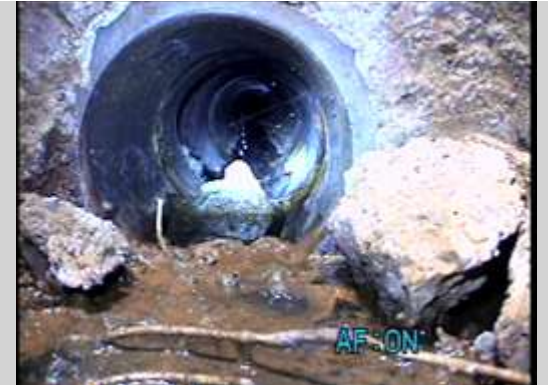
12 O'Clock Outflow

8 in. Circular Gravity Sewer  
Pipe Out @ 12 O'Clock

Infiltration: **None** Pipe Seal Cond: **Unknown**
